# California Department of Forestry and Fire Protection

## INVESTIGATION REPORT

**NAME:** Rice Fire

**CASE NO.** 07-CDF-572

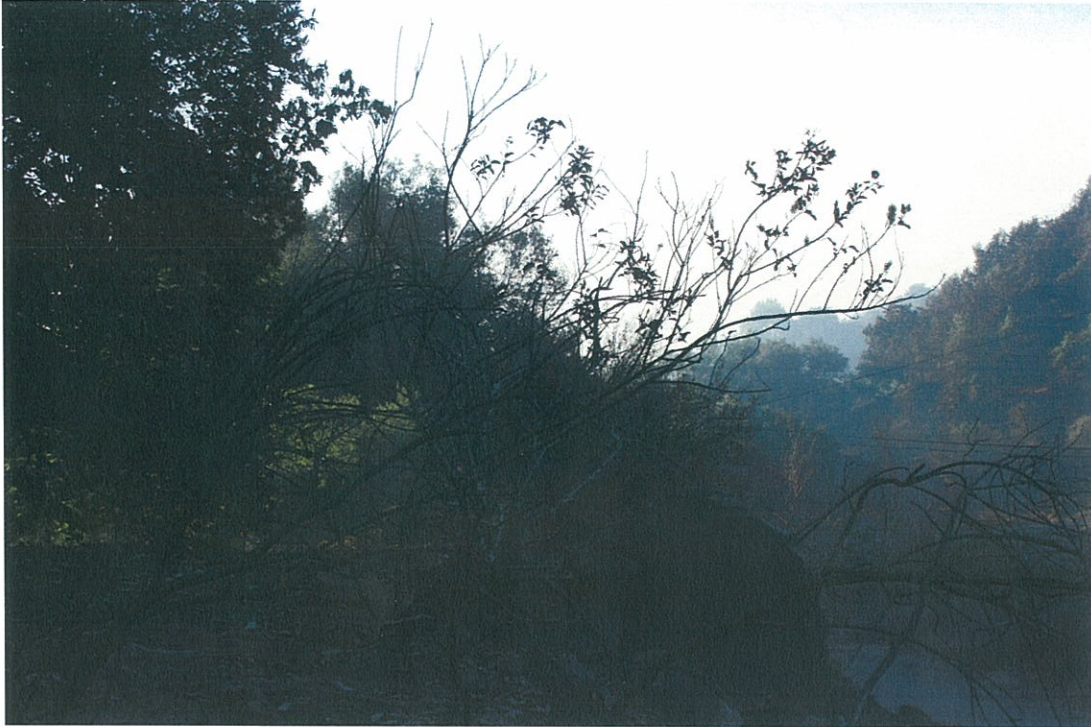
P-1 MG Overall view of angle of char showing advancing fire, east side of Rice Canyon

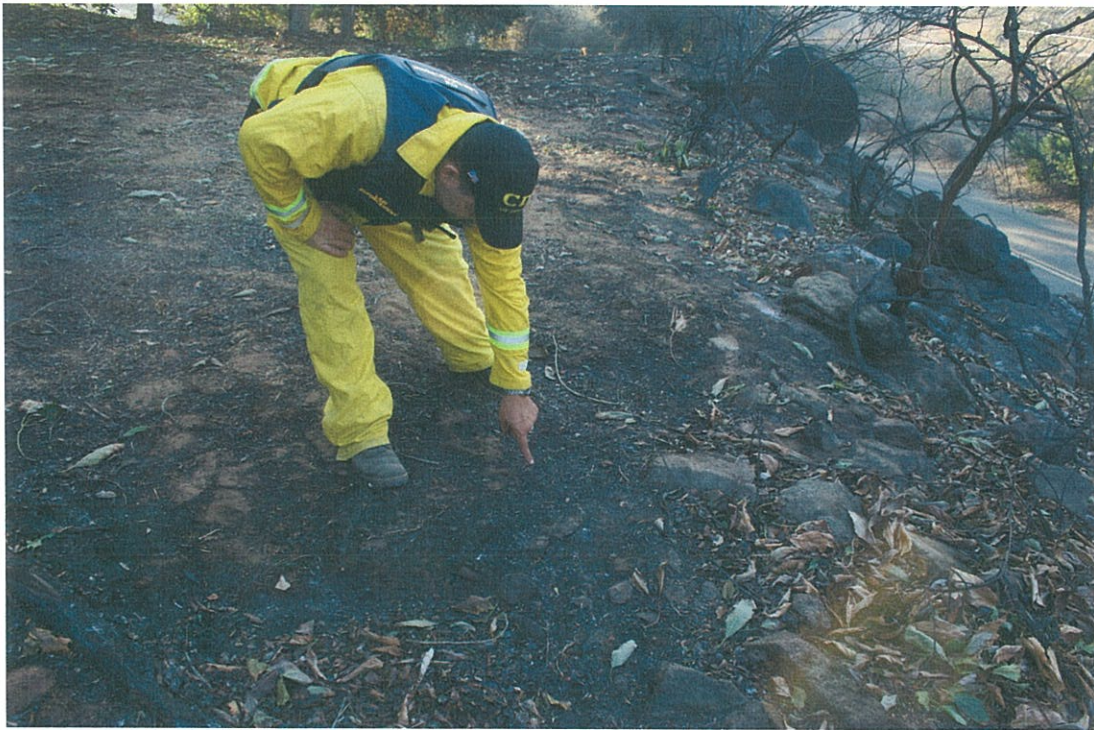
P-2 MG Overall view of indicators showing advancing fire

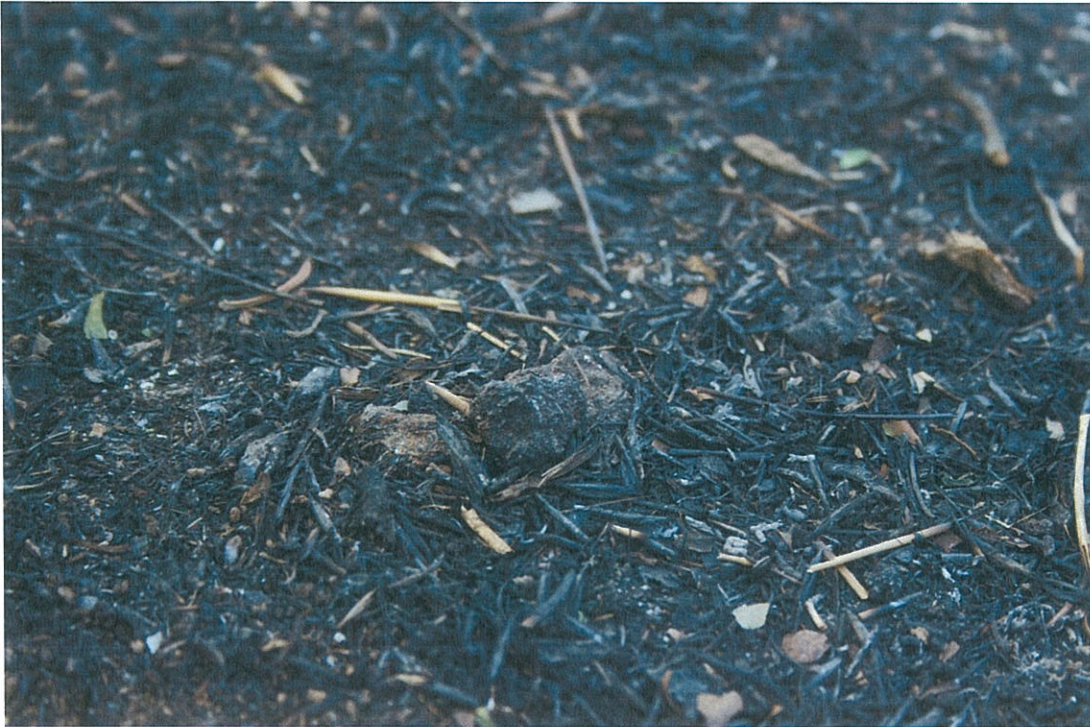
P-3 MG View of exposed side

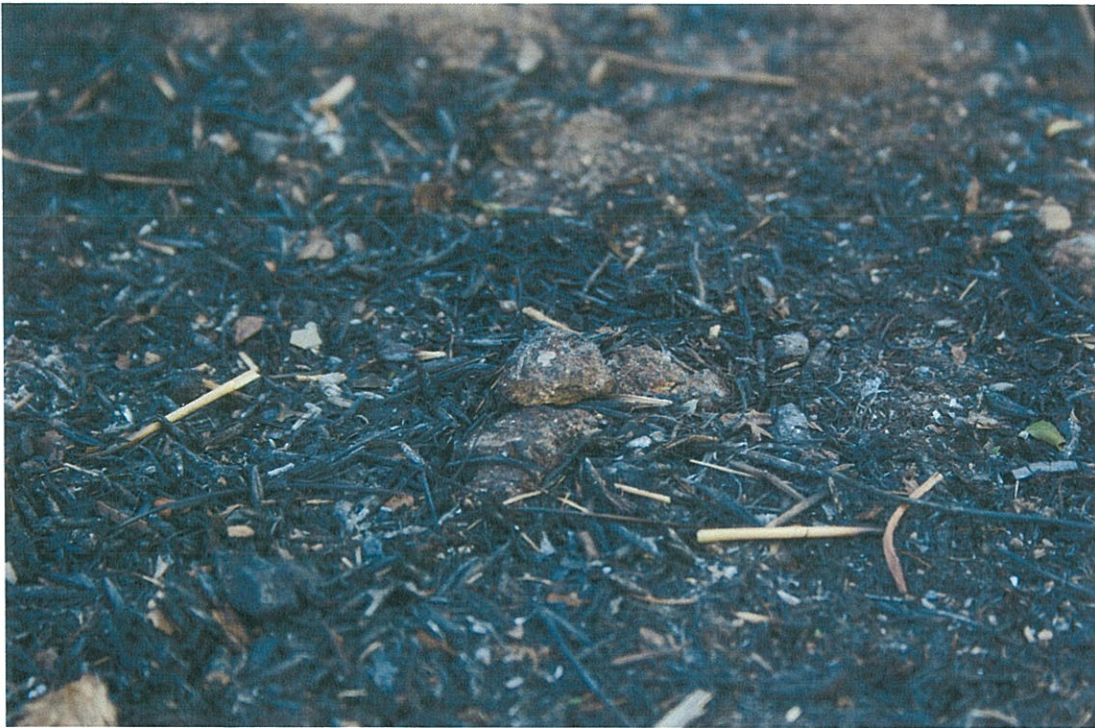
P-4 MG View of protected side

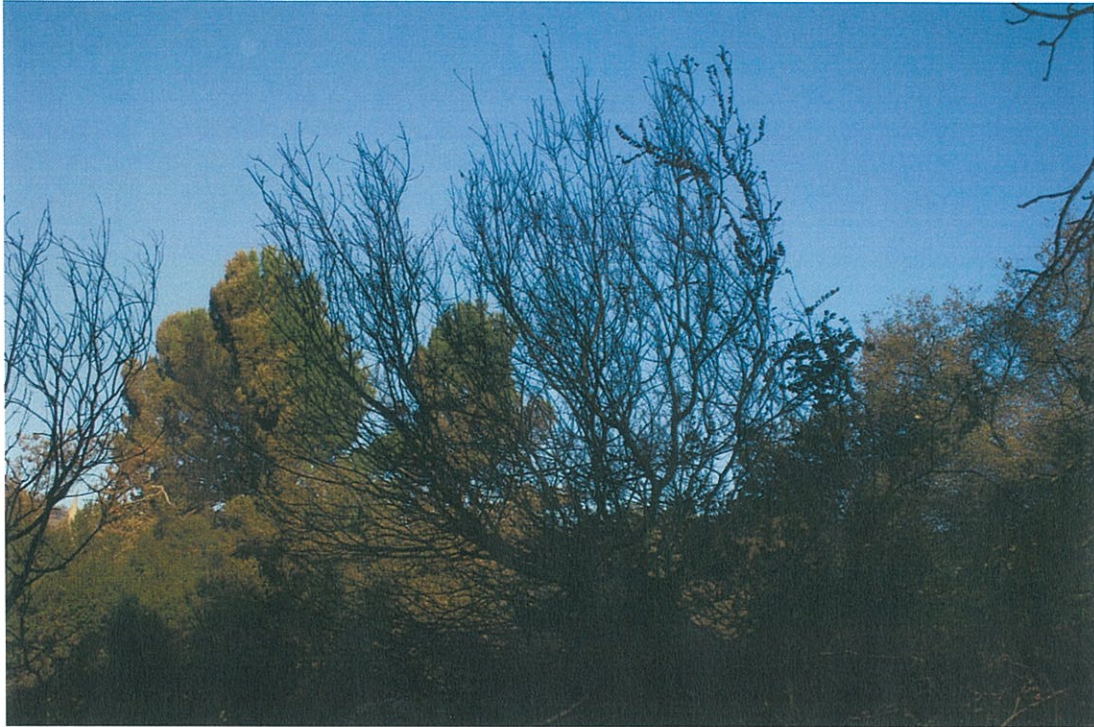
P-5 MG View of angle of char showing advancing fire

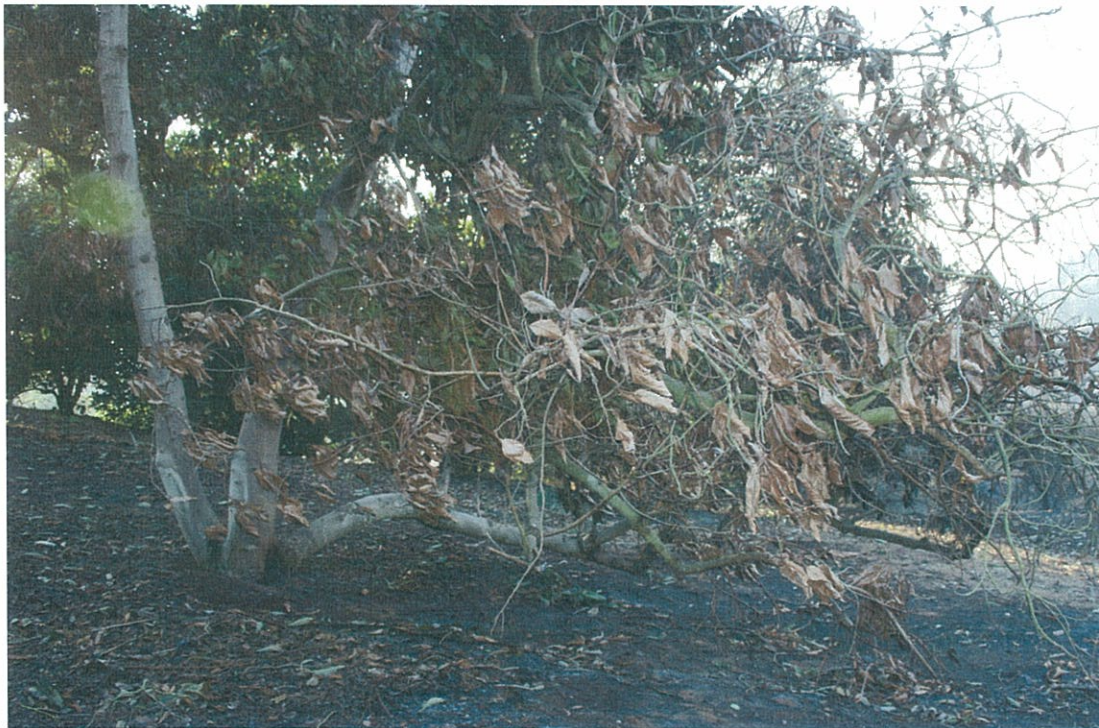
P-6 MG View of leaf freeze, showing wind direction

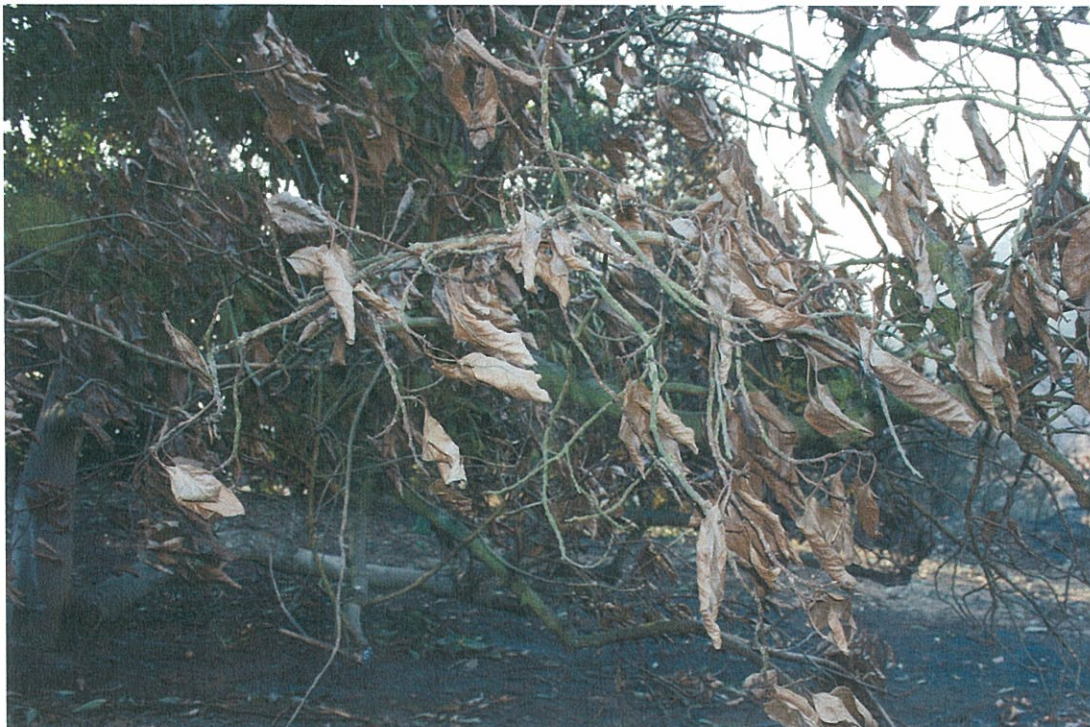
P-7 MG Close-up view of leaf freeze

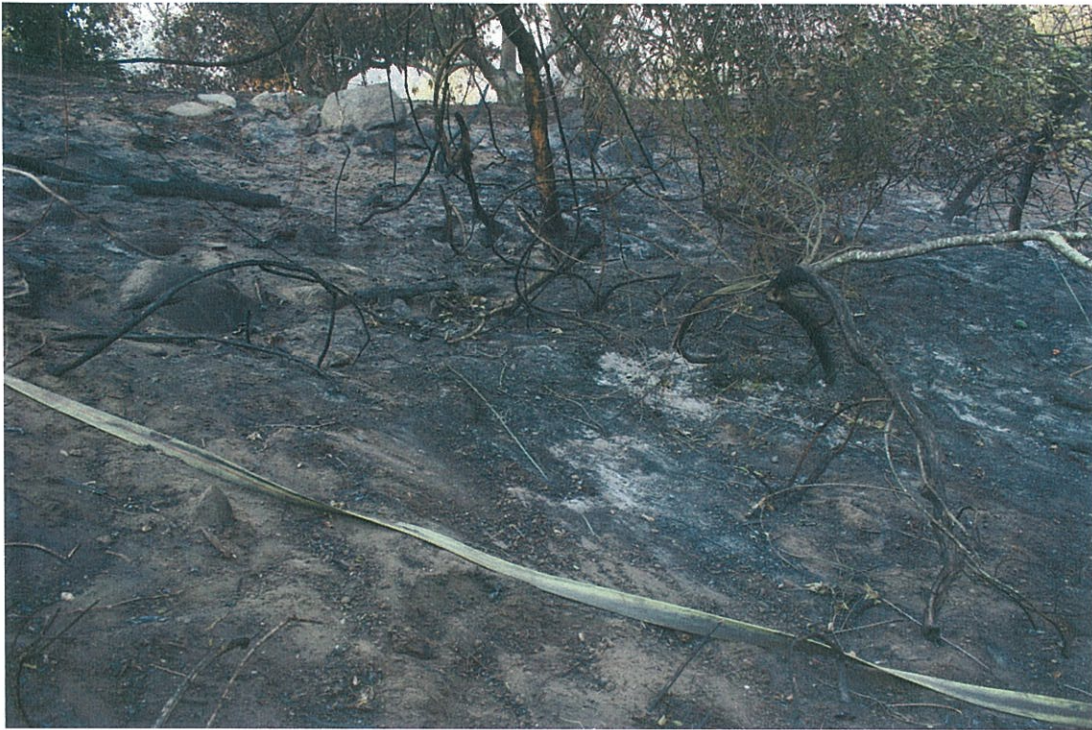
P-13 MG View of fire area

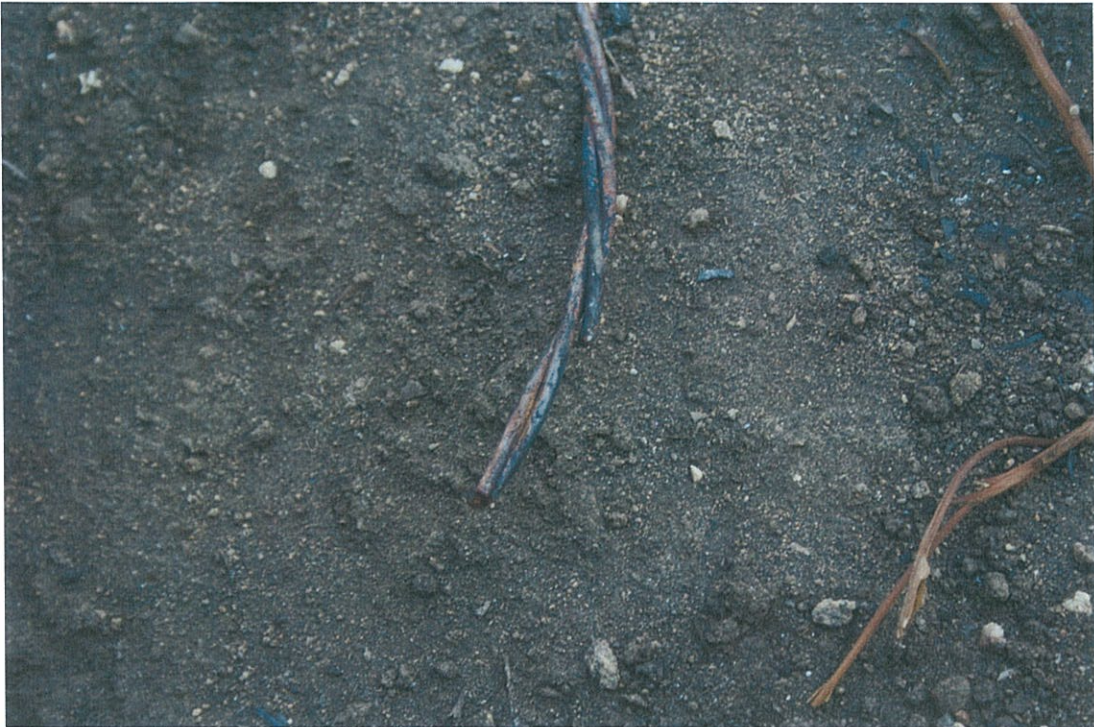
21 Power lines – During my investigation of Specific Origin Areas #1 and #2 I located  
22 downed power lines. Each line showed areas of spackling and arcing. Witness  
23 statements place the fire as being small in size near the areas I identified as the  
24 Specific Origin Areas and the power going out between 4:00 and 4:15 AM, which  
25 correlates to the estimate provided by SDG&E. During the course of the  
26 investigation I eliminated all other causes for the fire, determining the Rice Fire to  
27 be a power line caused fire.

P-15 MG View of power line

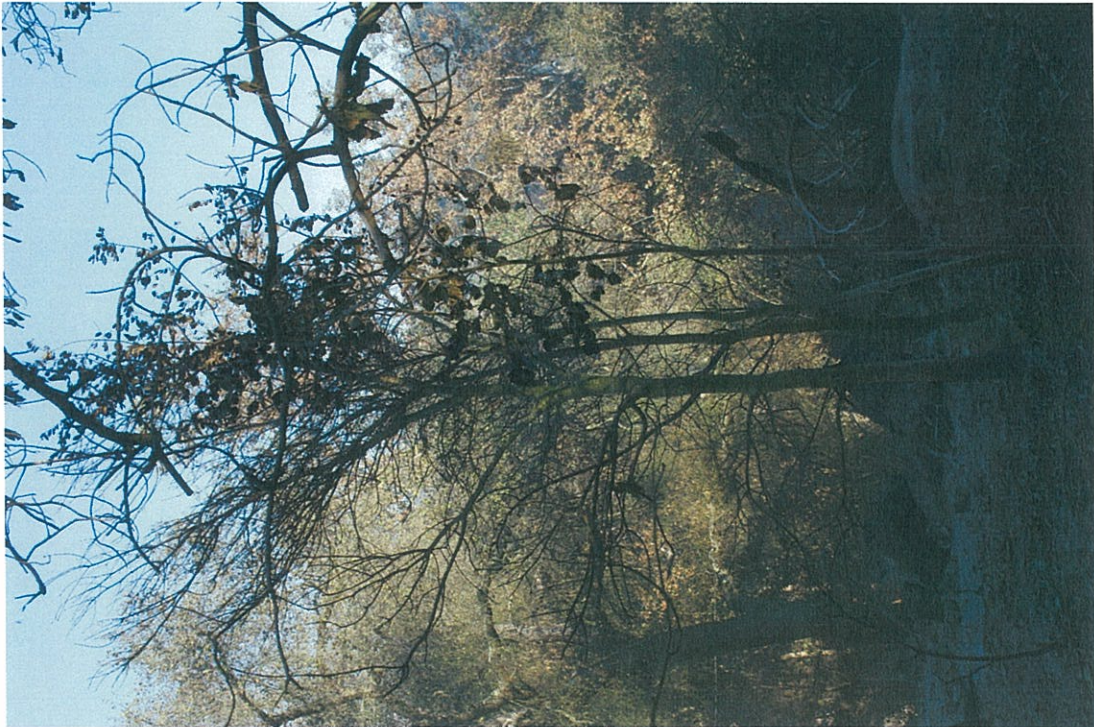
P-17 MG View of angle of char showing advancing fire

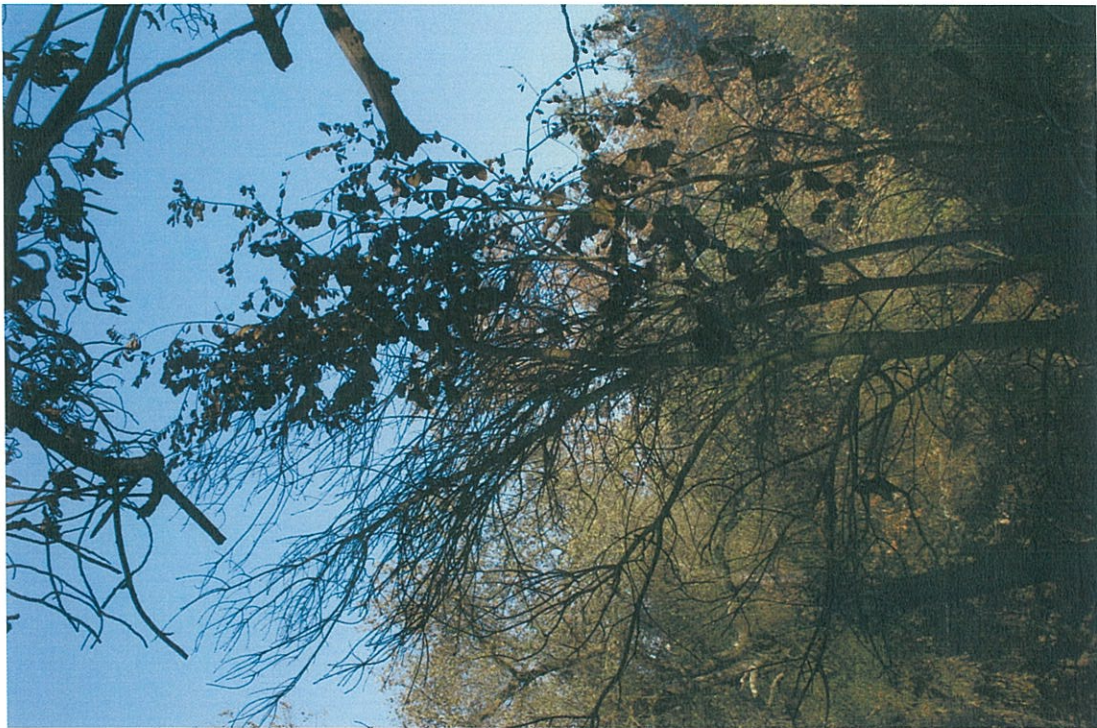
P-18 MG View of angle of char showing advancing fire

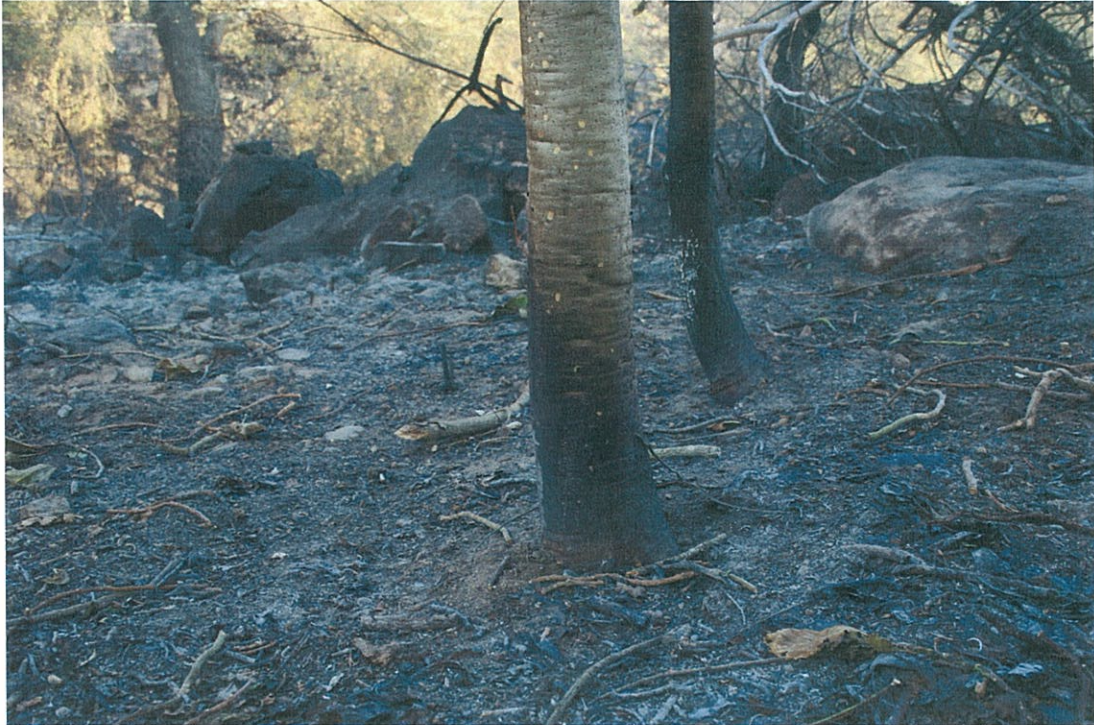
P-19 MG View of angle of char showing advancing fire

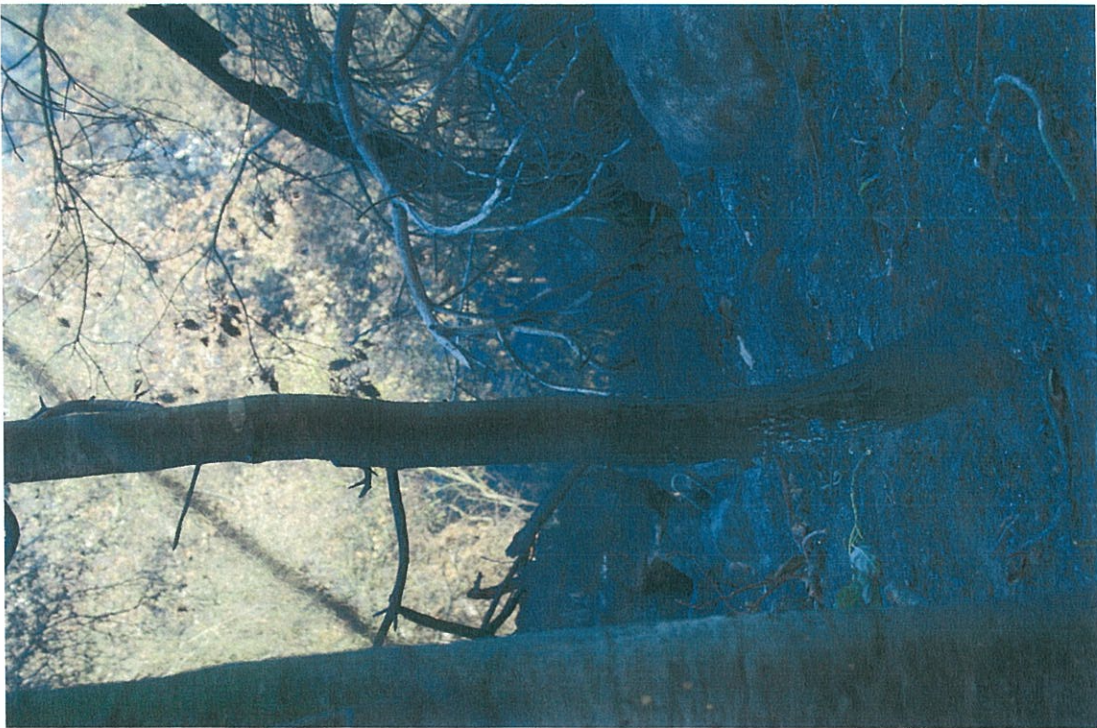
P-20 MG View of angle of char showing advancing fire

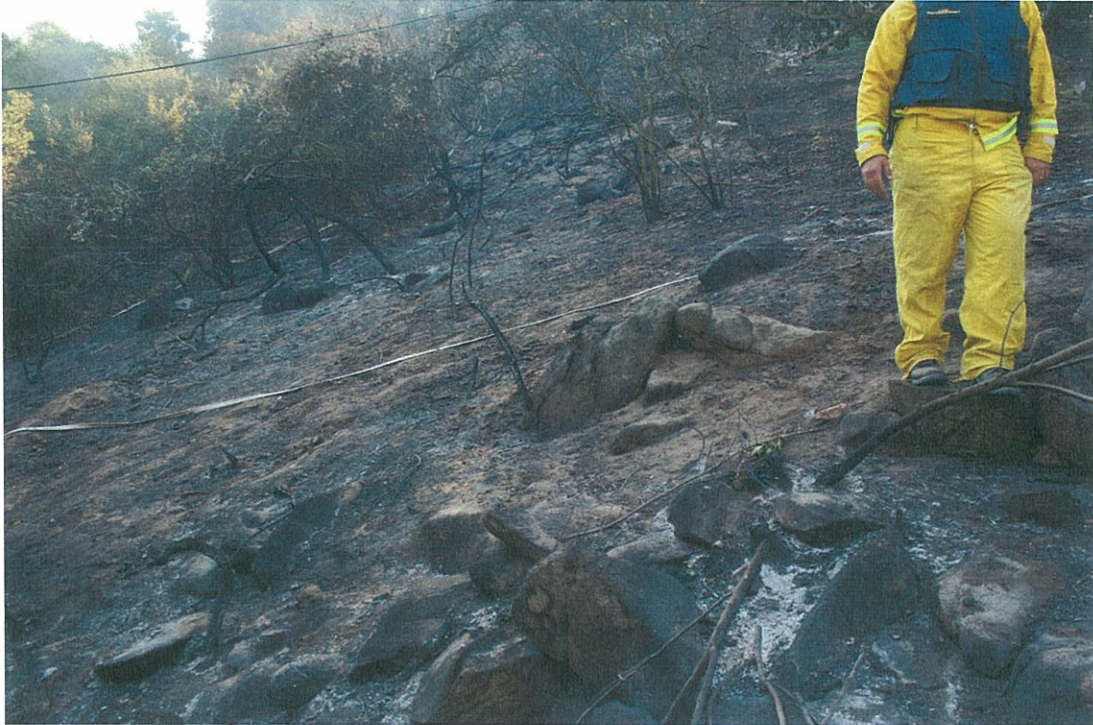
P-21 MG Overall view of rocks used to show advancing fire

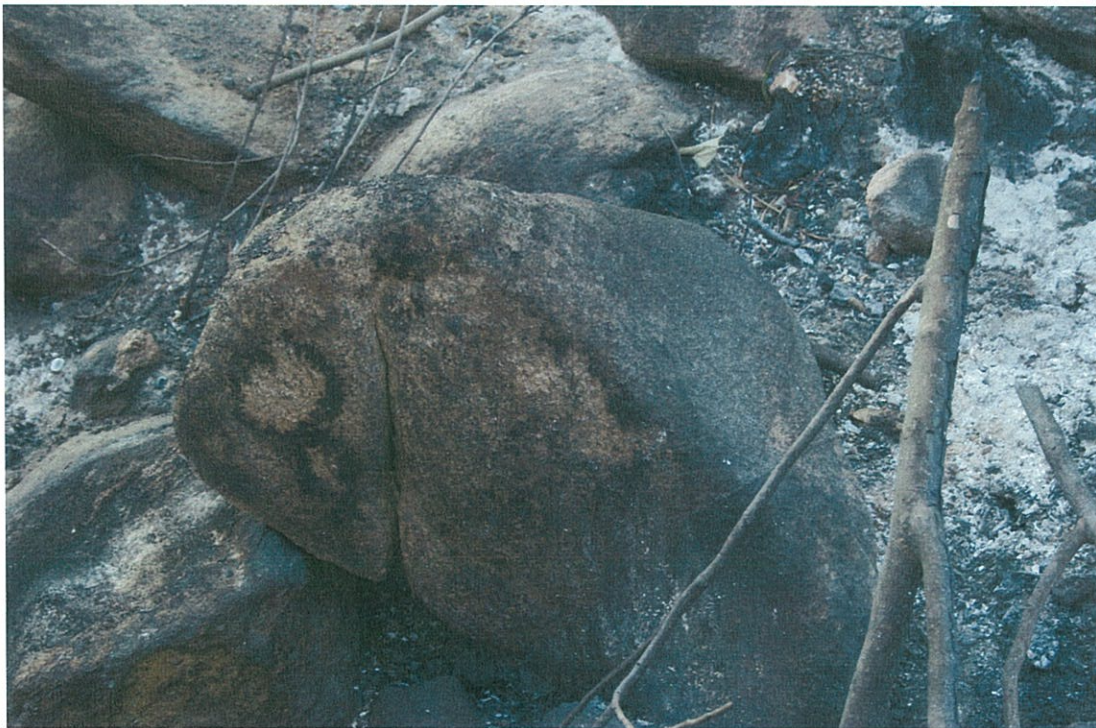
P-22 MG View of protected side of rock

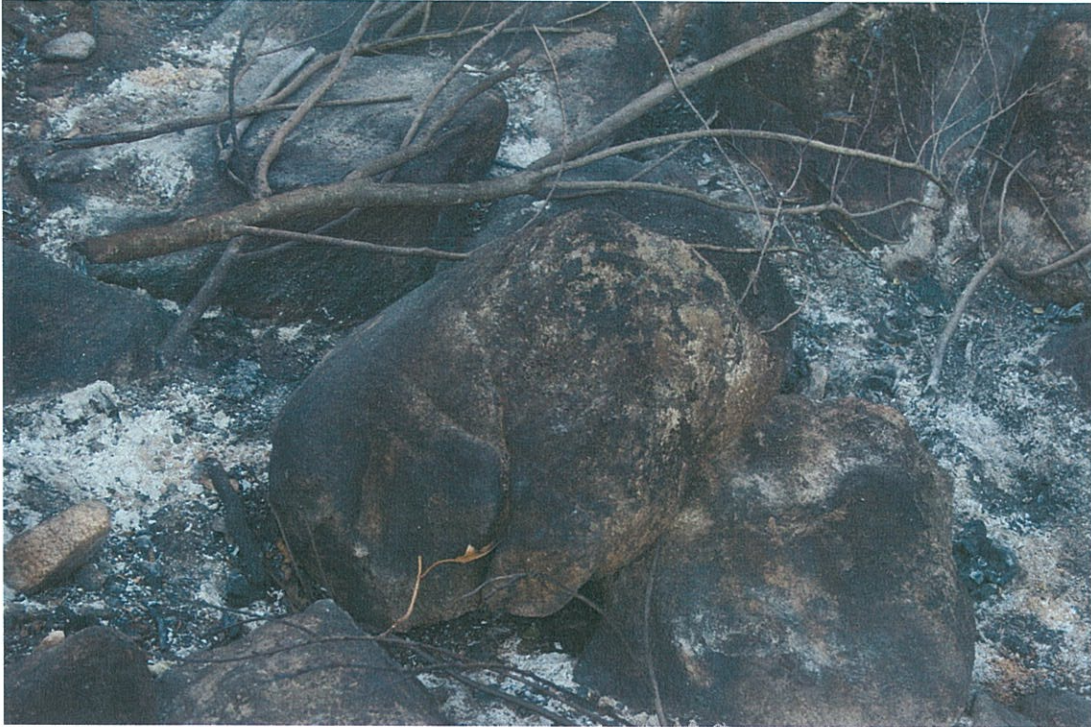
P-23 MG View of exposed side of rock

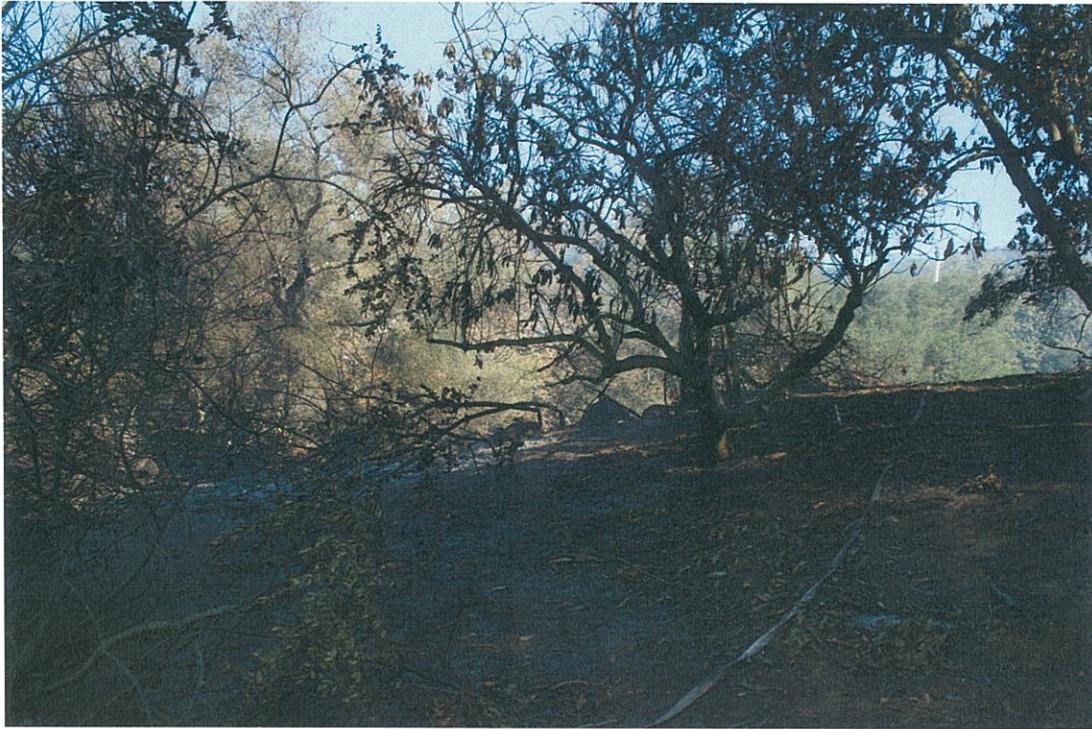
P-25 MG Overall view of Origin #1, with flags

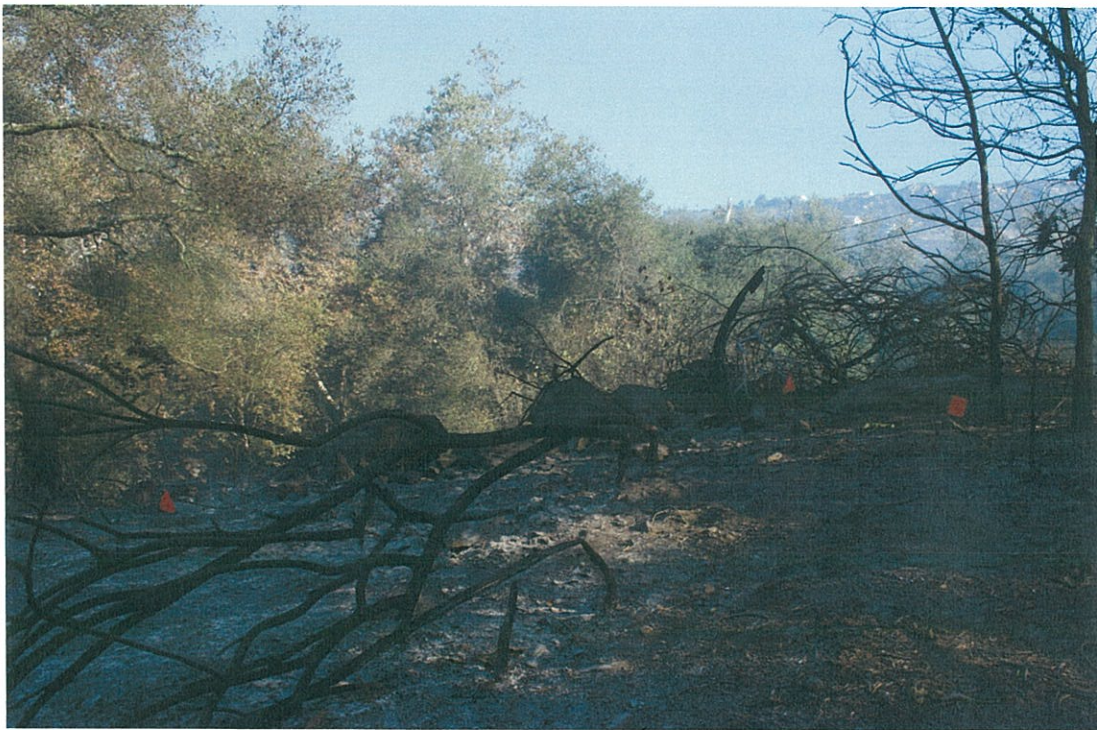
P-26 MG Overall view of advancing indicators

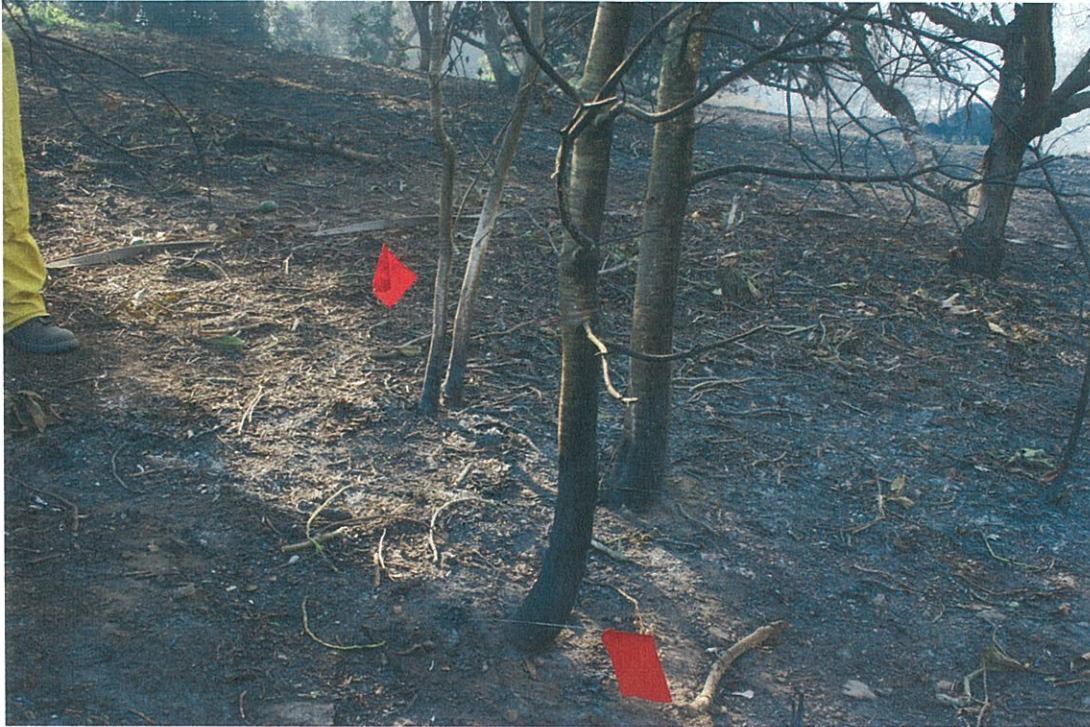
P-27 MG View of angle of char, showing advancing fire

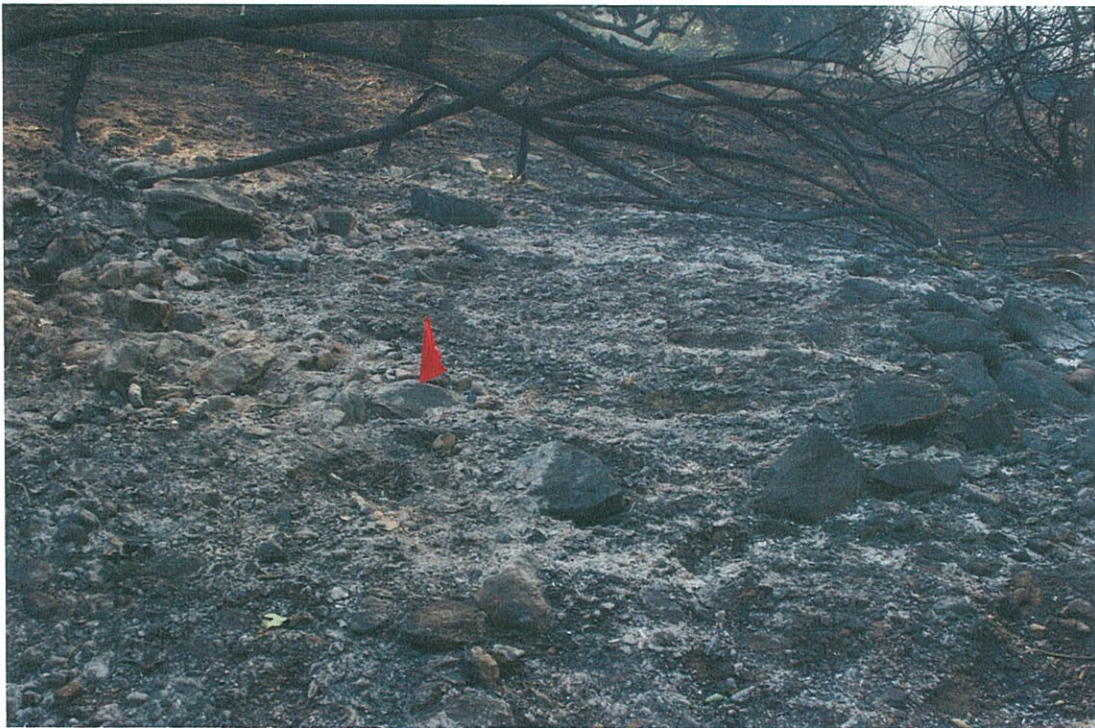
P-28 MG View of white ash, showing advancing fire

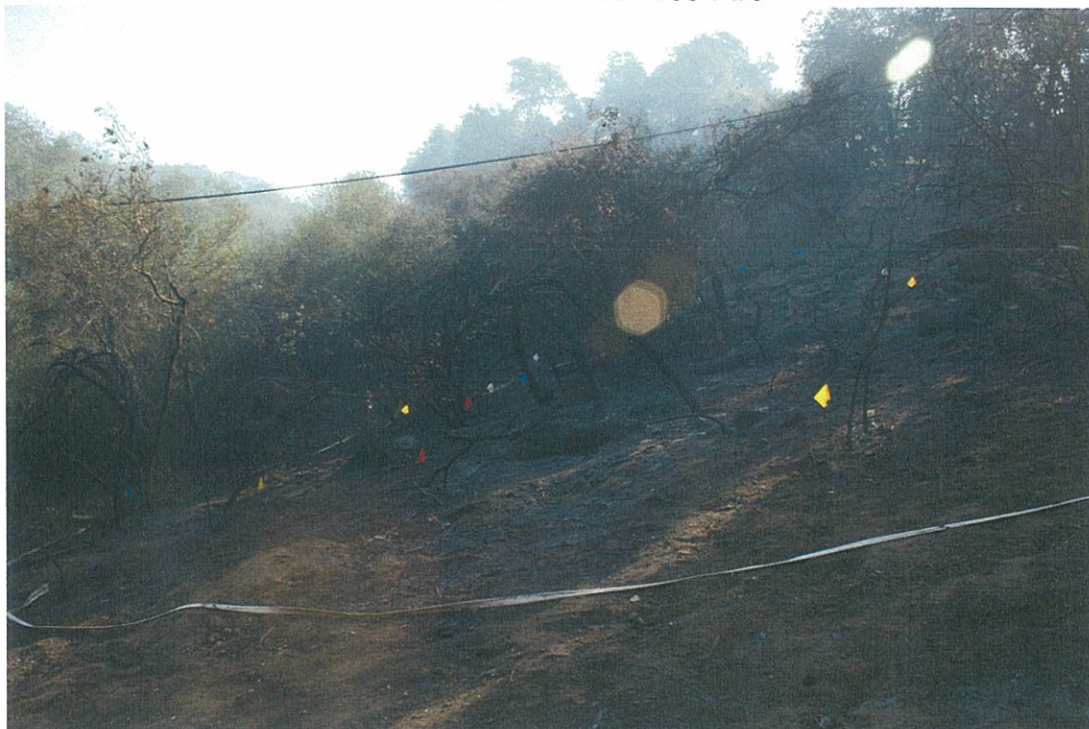
P-29 MG Overall view of Specific Origin Area, with flagging

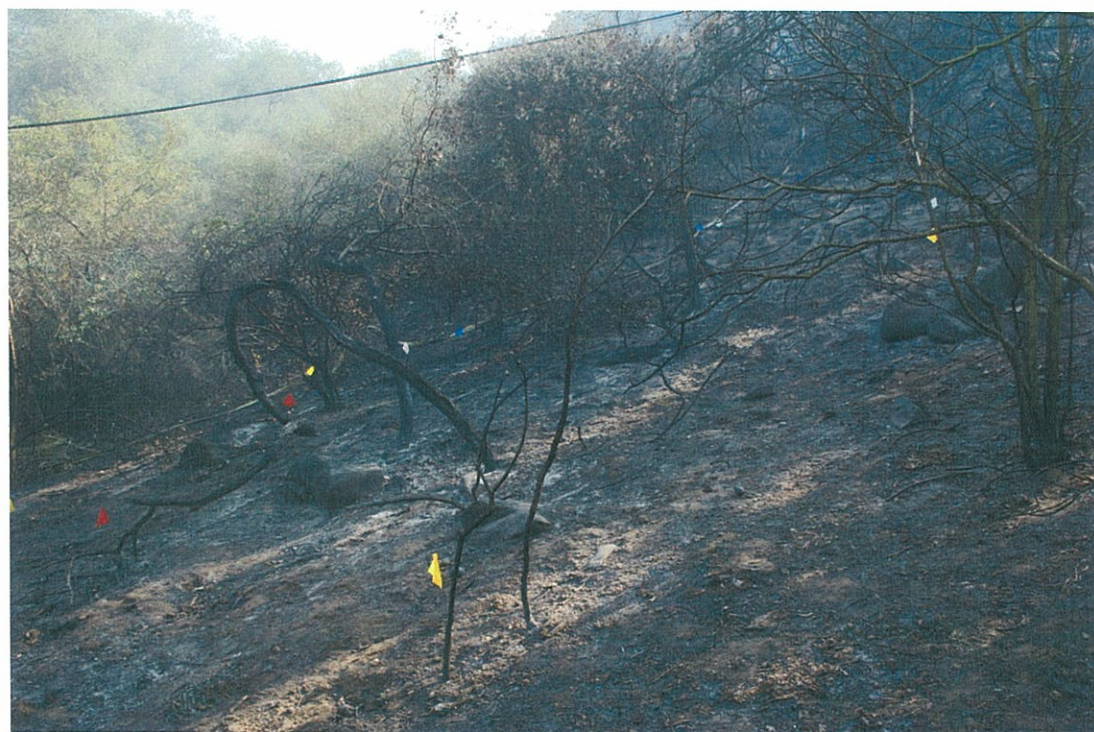
P-30 MG Overall view of Specific Origin Area

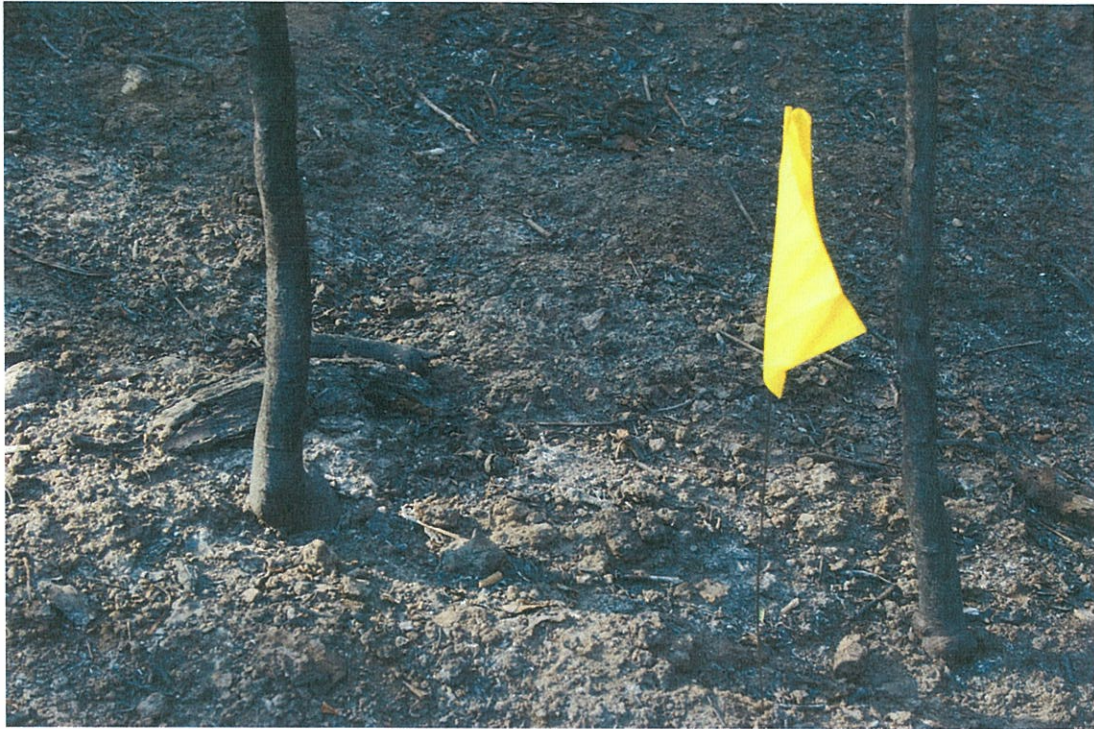
P-31 MG View of lateral movement of fire, exposed side

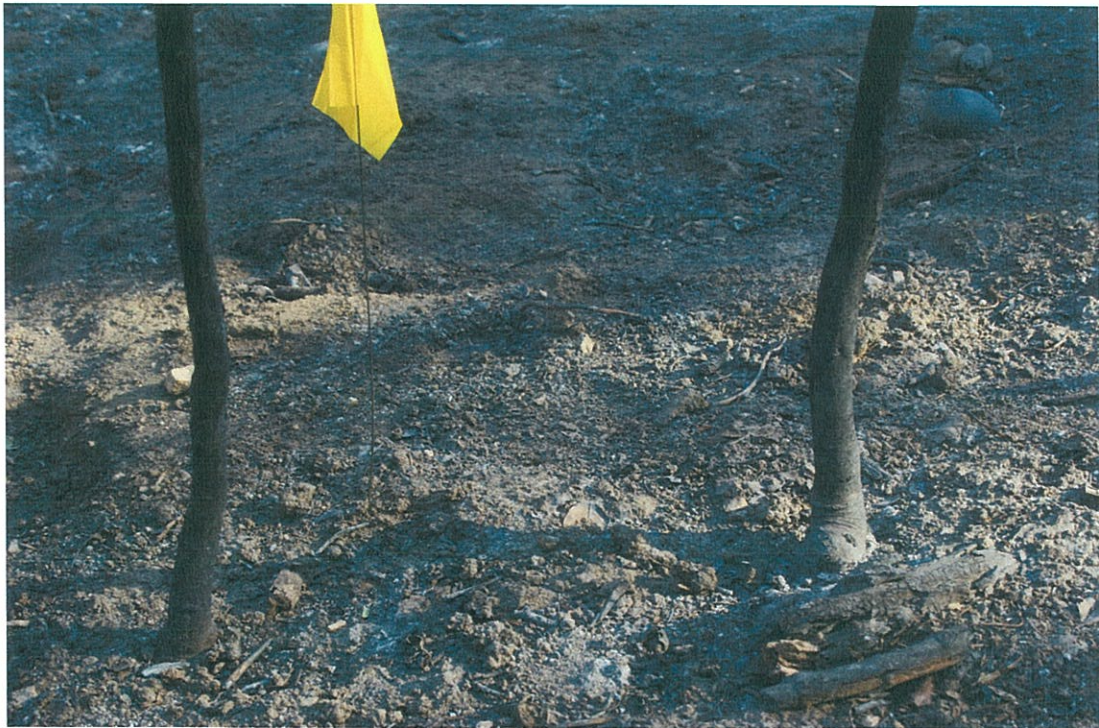
P-32 MG View of protected side

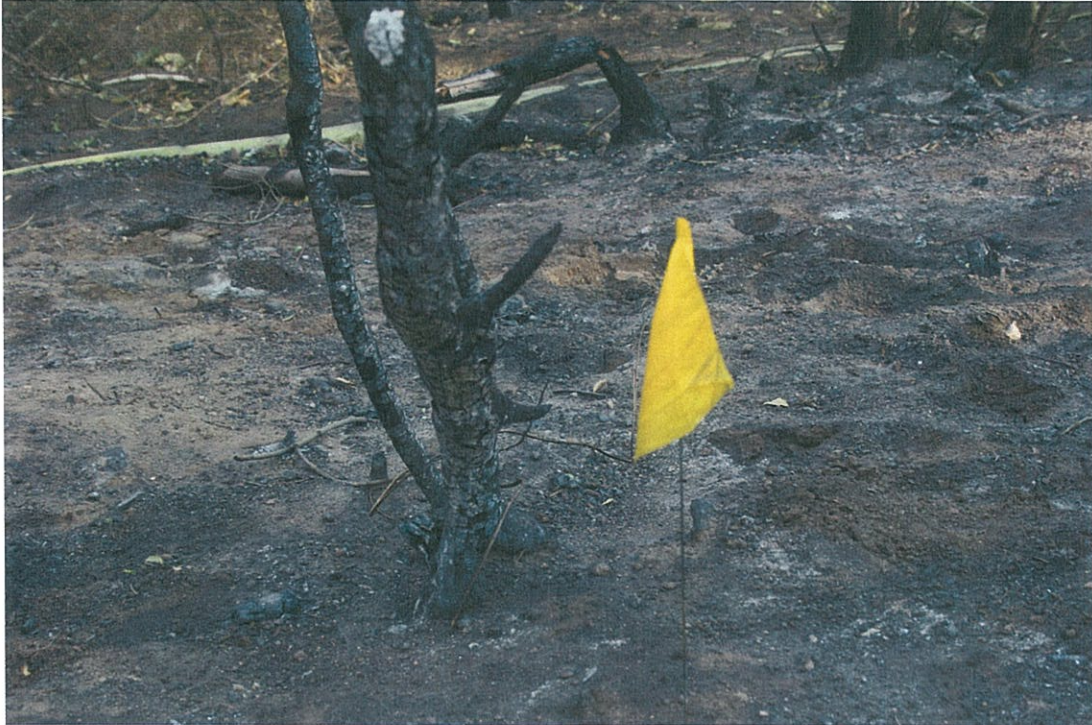
P-33 MG View of lateral fire, exposed side

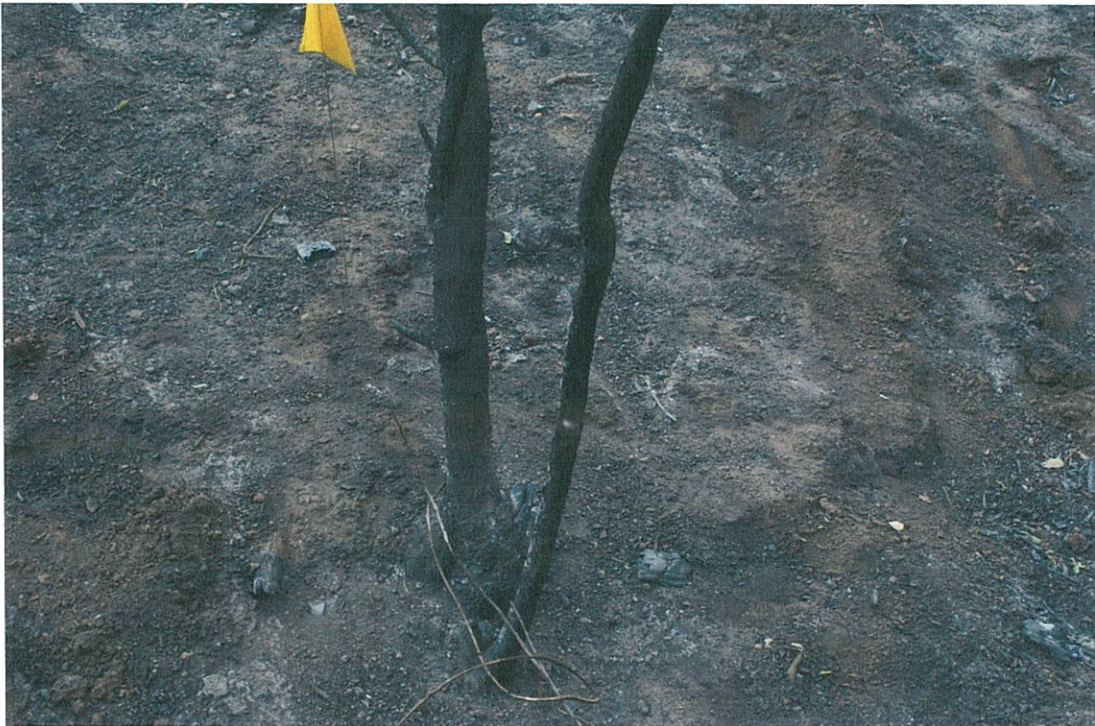
P-34 MG View of protected side

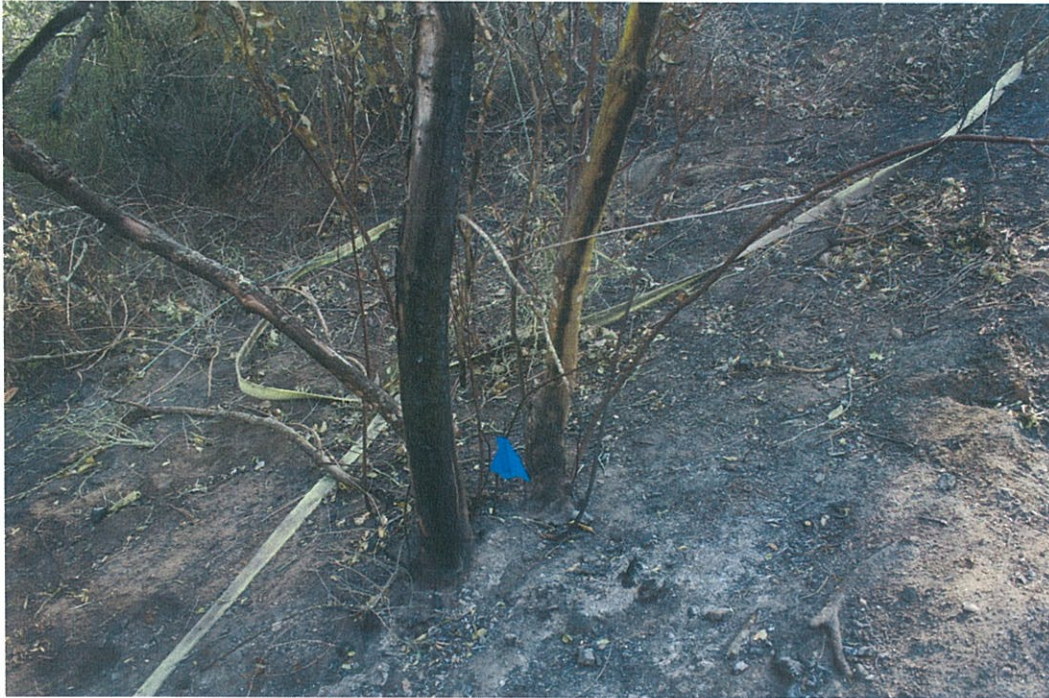
P-35 MG View of backing fire, exposed side

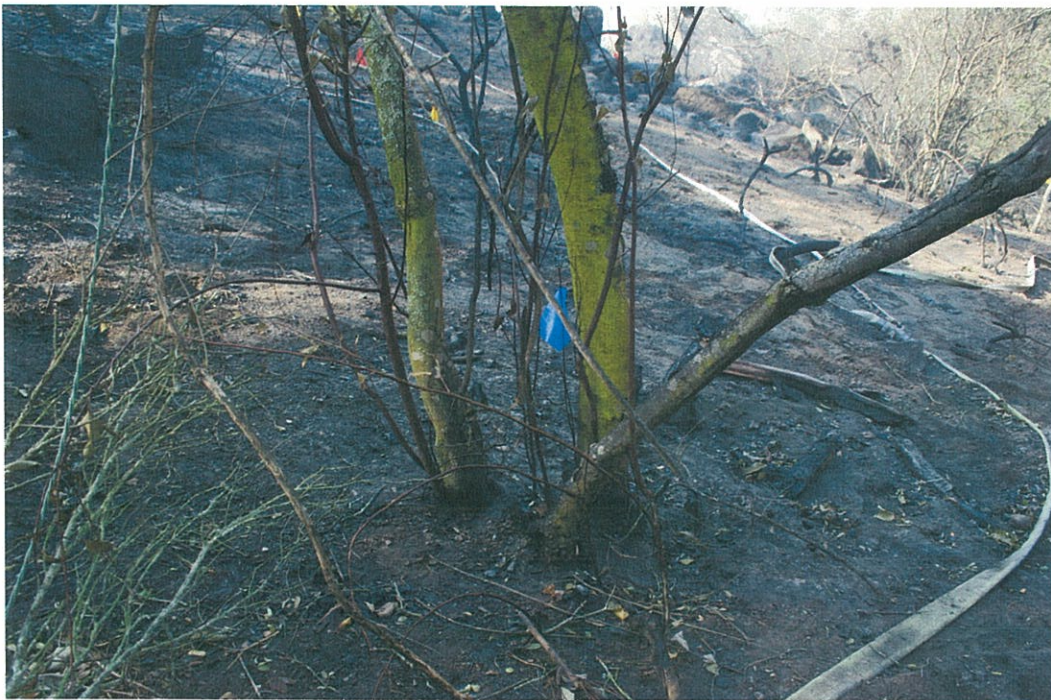
P-36 MG View of backing fire, protected side
